DEPARTMENT OF THE NAVY  
COMMANDER U.S. THIRD FLEET  
63690 TOMAHAWK DR STE 388  
SAN DIEGO, CALIFORNIA 92147-6004

Subj: COMMAND INVESTIGATION INTO THE COLLISION BETWEEN USS  
ESSEX (LHD 2) AND USNS YUKON (T-AO 202) THAT OCCURRED ON  
16 MAY 2012

1. In accordance with reference (a), I convened a command investigation to inquire into the facts and circumstances surrounding the collision between USS ESSEX (LHD 2) (ESX) and USNS YUKON (T-AO 202) (YUK) which occurred on 16 May 2012. My convening order directed the Investigating Officer to investigate all facts and circumstances surrounding this incident, including the cause, and any fault, neglect, or responsibility thereof.

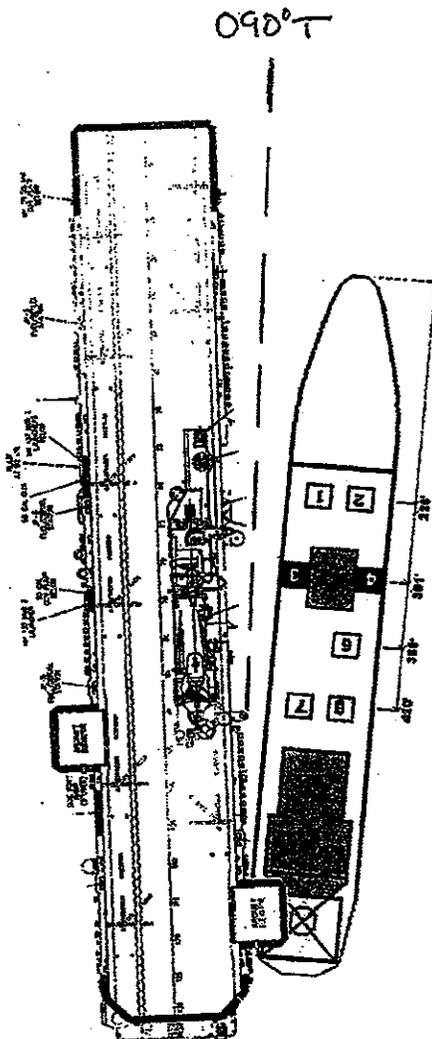
**FIGURE I: Collision Point for USS ESSEX (LHD 2) and  
USNS YUKON (T-AO 202)**
